SPECIAL REPORT ON ANADROMOUS STREAM SURVEYS OF CLEVELAND
PENINSULA, INCLUDING EMERALD BAY, VIXEN INLET, UNION BAY,
CLARENCE STRAIT, BOND BAY, SPACIOUS BAY, AND PORTIONS OF
PORT STEWART AND HELM BAY

Subdistricts 107-10 and 102-80

March 1985

Alaska Department of Fish and Game
Division of Commercial Fisheries
Petersburg, Alaska

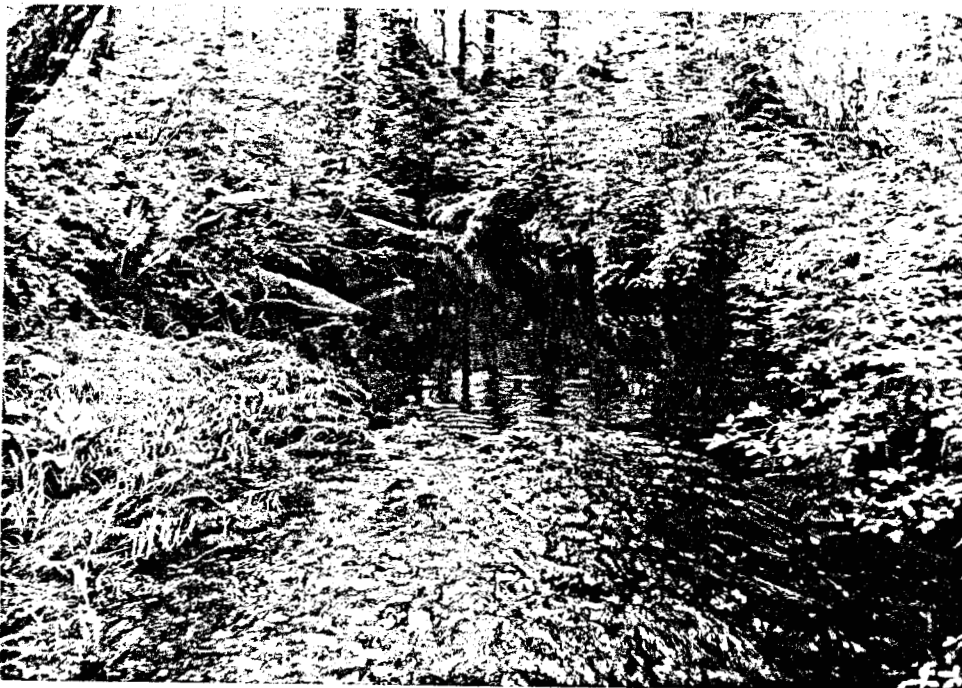
4. Section 27: Improved rearing habitat and ASA are found in Reach 2.

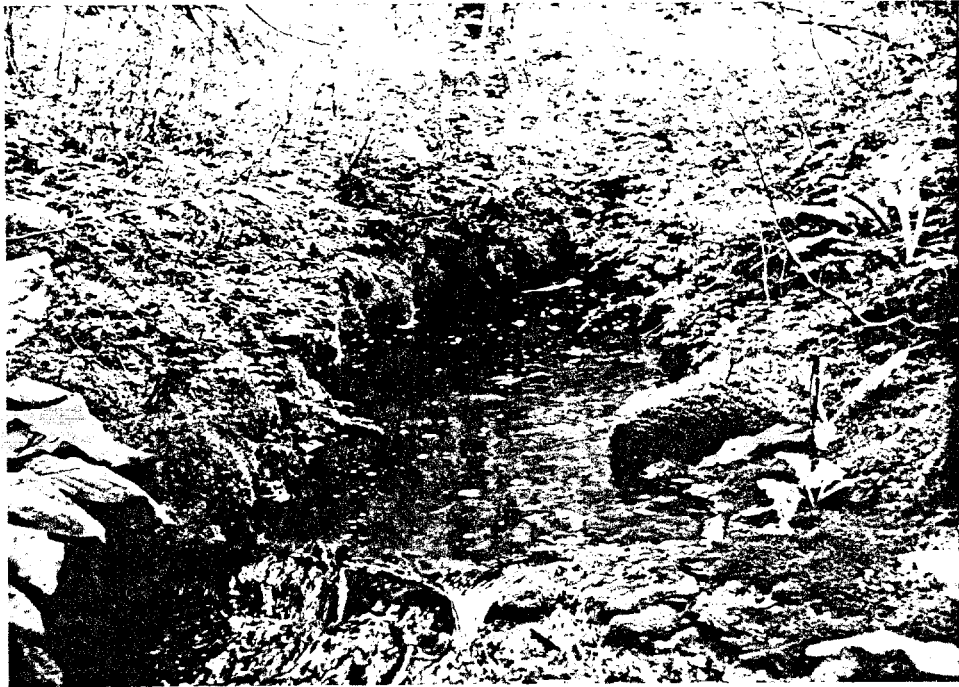
5. Typical habitat at the end of the survey - Section 34.

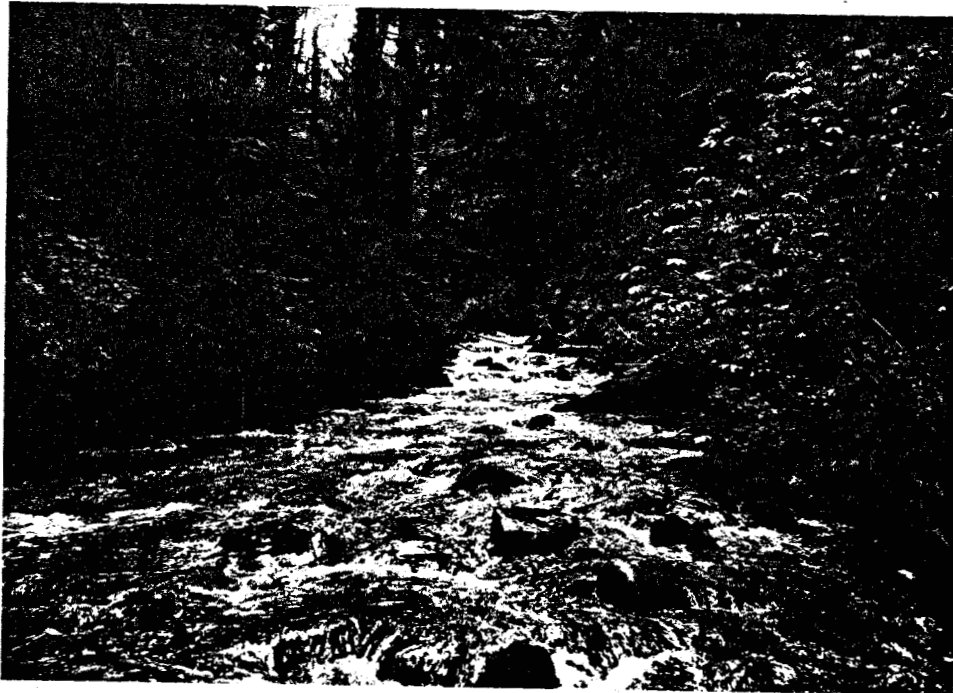
4. Poor habitat at end of survey - Section 48.

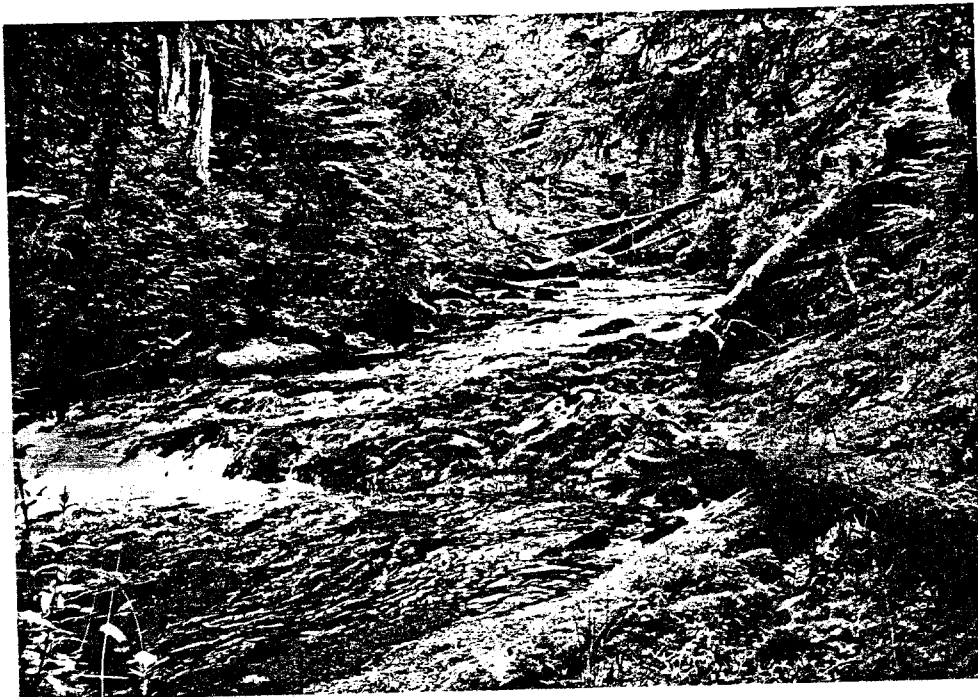
3. Section 29: Poor rearing and ASA were provided by the predominately bedrock substrate of Reach 4.

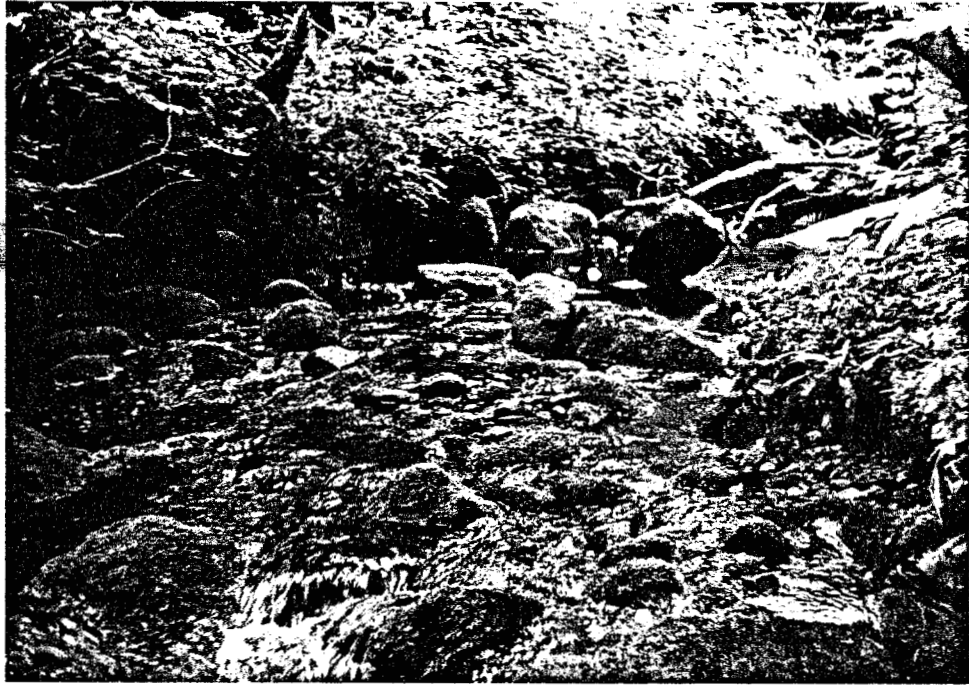
3. Section 5. Substrate size and gradient increase.

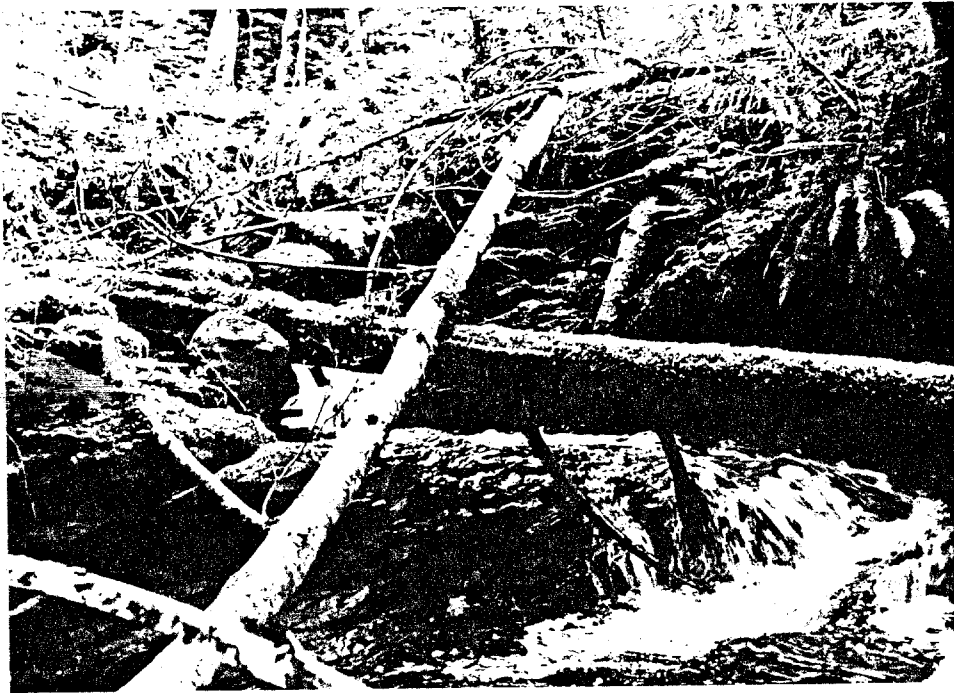
3. Section 2: Potential PS barrier at end of Section.

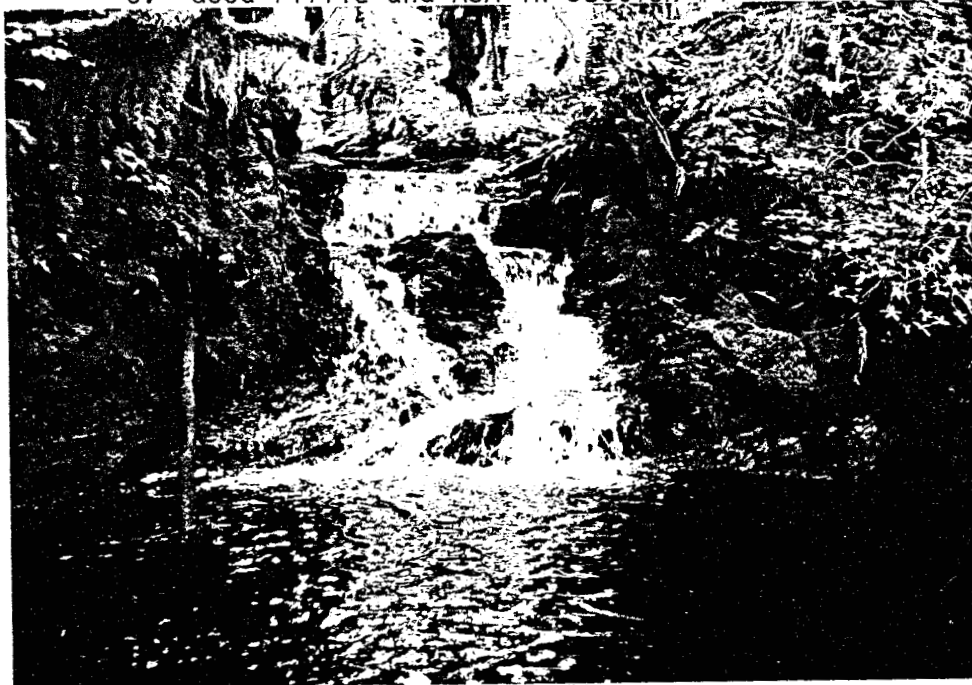
4. 2 m. falls in Section #6.

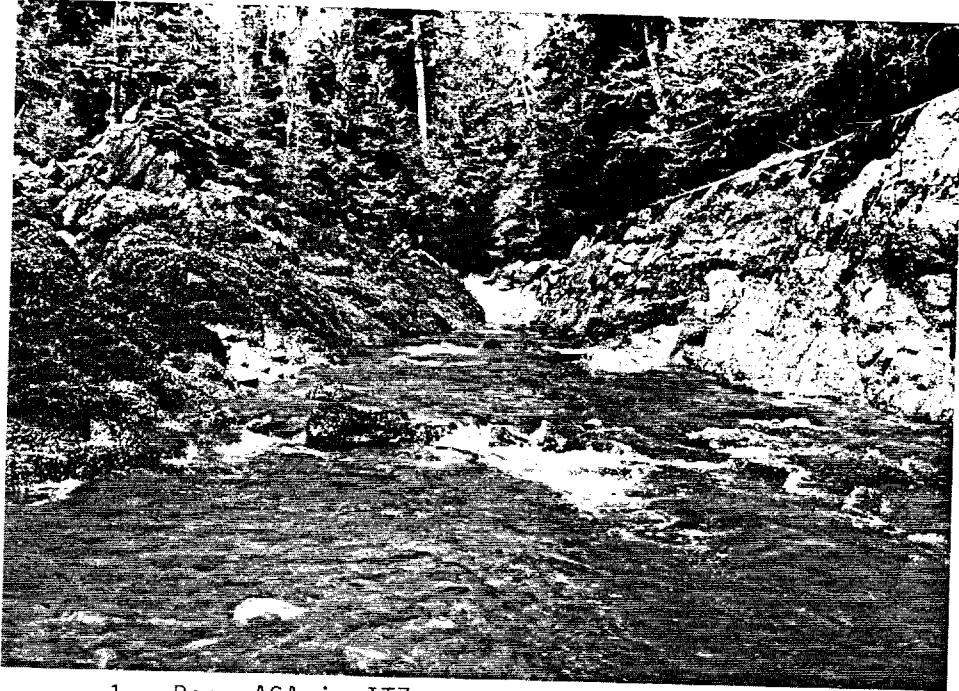
1. Poor ASA in ITZ.
